# STM32F20x and STM32F21x Errata sheet

## STM32F205/207xx and STM32F215/217xx revision Y device limitations

This errata sheet applies to the revision Y (cut2.1) of STMicroelectronics STM32F205xx/STM32F207xx and STM32F215xx/STM32F217xx microcontroller families. In this document they will be referred to as STM32F20x and STM32F21x, respectively, unless otherwise specified.

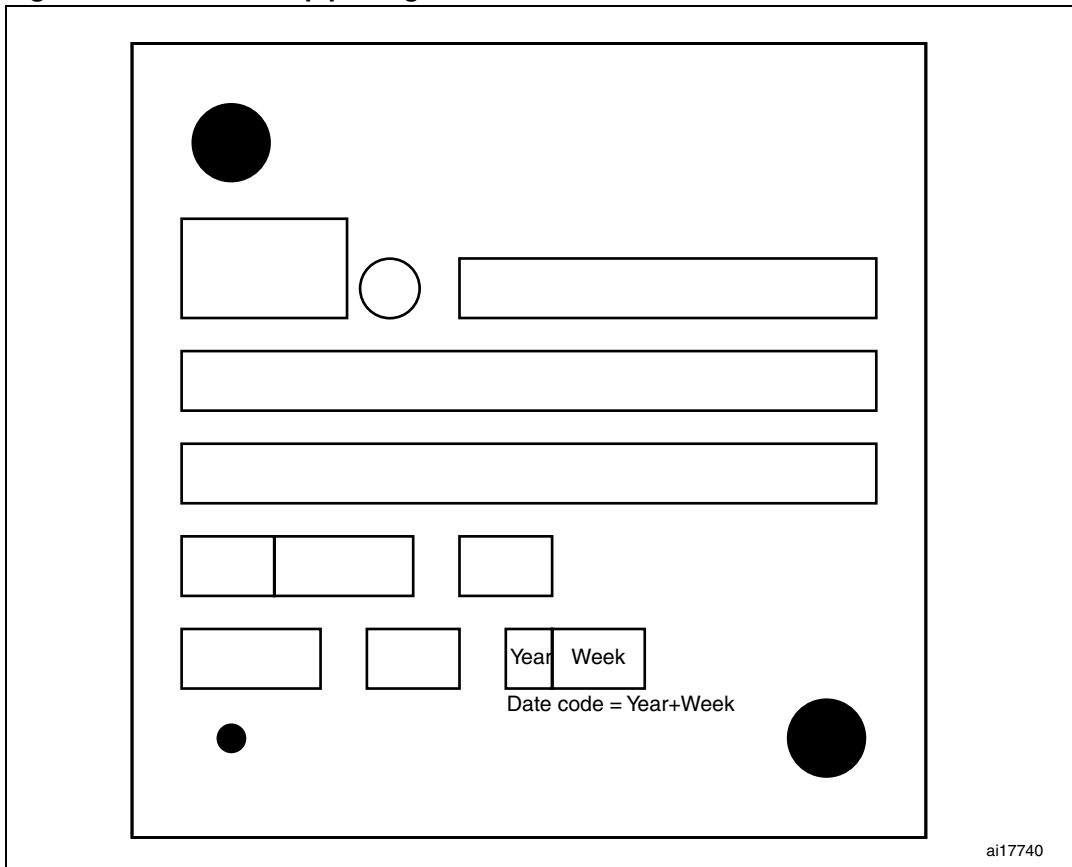
Figure 3. LQFP176 top package view

Figure 3, Figure 4, Figure 5 and Figure 6 show the marking compositions for the LQFP144, LQFP100 and LQFP64 packages, respectively. The only fields shown are the Additional field containing the revision code and the Year and Week fields making up the date code.
